NON DESTRUCTIVE TESTING REPORT

**Wire Rope
Report**

**Denman Island Cable Ferry
British Columbia
Ferry Services Inc.**

Job #: 7198
Date: April 19, 2016

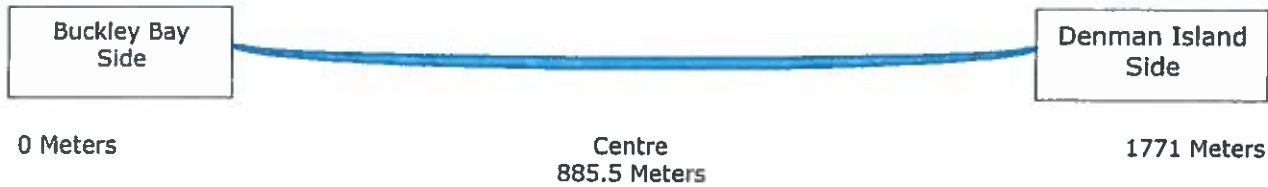
BC Ferry Services Inc. - North Rope ~ April 19, 2016

Rope:	Denman Island Cable Ferry – North Rope
Previously was the Drive Rope in November 2015:	(2) anomalies
Number of anomalies in April 2016:	27
Average diameter measured:	1.67"
Minimum diameter measured:	1.64"
Number of diameter measurements taken:	17

Denman Island Ferry - North Rope			
Rope Construction:	6 X 19 Seale	Length:	1771 meters
Sens:	2.42 - 2.05	Diameter:	1 5/8"
Machine Used:	LMA 300 (C)	Av. Diameter:	1.67"
Location	Comments	Location	Comments
0	Start of test at Buckley Bay side		
31	Two (2) calibration wires - 3" long		
32	One (1) calibration wire - 3" long		
457	One (1) broken wire		
476	Two (2) broken wires

476.5	One (1) broken wire		
478	One (1) broken wire		
480	One (1) broken wire		
596	One (1) broken wire		
642	One (1) broken wire		
648	One (1) broken wire		
652	One (1) broken wire		
655	One (1) broken wire		
774	One (1) broken wire		
794	One (1) broken wire		
1150	Two (2) broken wires		
1151	Nick/abrasion		
1152	Nick/abrasion		
1161	Two (2) broken wires		
1162	Nick/abrasion		
1171	One (1) broken wire		
1176	Two (2) broken wires		
1177	One (1) broken wire		
1180	Two (2) broken wires		
1198	Two (2) broken wires		
1218	Two (2) broken wires		
1771	End of test at Denman Island Side		
Comments:	Untested cable: Denman Island to test head - approximately 30 meters and test head to excess cable on Buckley Bay - approximately 350 meters. Approximately 380 meters of cable not tested.		
Specification:	Quality Control

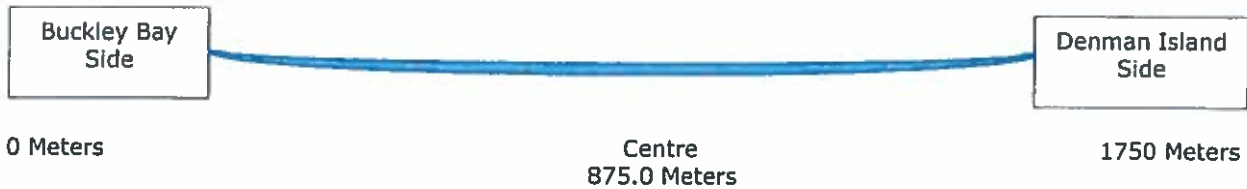
BC Ferry Services Inc. - South Rope - April 19, 2016

Rope:	Denman Island Cable Ferry – South Rope
Previously was the North Rope in November 2015:	(3) anomalies
Number of anomalies in April 2016:	57
Average diameter measured:	1.67"
Minimum diameter measured:	1.66"
Number of diameter measurements taken:	17

Denman Island Ferry - South Rope			
Rope Construction:	6 X 19 Seale	Length:	1750 meters
Sens:	2.42 - 2.05	Diameter:	1 5/8"
Machine Used:	LMA 300 (C)	Av. Diameter:	1.67"
Location	Comments	Rope Speed:	1.2 m/sec (2.5 knots)
0	Start at Buckley Bay side	Location	Comments
30	Two (2) calibration wires - 3" long	Continued	
362	1+1 broken wires & nick/abrasion	1107	One (1) broken wire
387	Two (2) broken wires	1112	One (1) broken wire
613	One (1) broken wire	1115	One (1) broken wire
754	One (1) broken wire	1116	One (1) broken wire
903	One (1) broken wire	1118	One (1) broken wire
908	One (1) broken wire	1119	One (1) broken wire
1021	One (1) broken wire	1125	One (1) broken wire
1024	One (1) broken wire	1127	One (1) broken wire
1025	One (1) broken wire	1128	One (1) broken wire
1029	One (1) broken wire	1129	One (1) broken wire
1044	One (1) broken wire	1134	One (1) broken wire
1050	One (1) broken wire	1135	One (1) broken wire

1054	One (1) broken wire	1140	One (1) broken wire
1056	One (1) broken wire	1141	One (1) broken wire
1057	One (1) broken wire	1144	One (1) broken wire
1062	One (1) broken wire	1146	One (1) broken wire
1064	One (1) broken wire	1147	One (1) broken wire
1070	One (1) broken wire	1149	One (1) broken wire
1078	One (1) broken wire	1152	One (1) broken wire
1086	One (1) broken wire	1153	One (1) broken wire
1088	One (1) broken wire	1156	One (1) broken wire
1090	One (1) broken wire	1157	One (1) broken wire
1095	One (1) broken wire	1158	One (1) broken wire
1097	One (1) broken wire	1163	One (1) broken wire
1098	One (1) broken wire	1164	One (1) broken wire
1103	One (1) broken wire	1165	One (1) broken wire
1104	One (1) broken wire	1740	Two (2) broken wires - not visible
Continued...		Some rope distortion - previously identified	
		1750	End of test Denman Island side
Comments:	Untested cable: Denman Island to test head - approximately 30 meters and test head to excess cable on Buckley Bay - approximately 350 meters. Approximately 380 meters of cable not tested.
