## NON DESTRUCTIVE TESTING REPORT

# Wire Rope Report

**Denman Island Cable Ferry  
British Columbia  
Ferry Services Inc.**

Job #: 7198  
Date: July 20, 2016

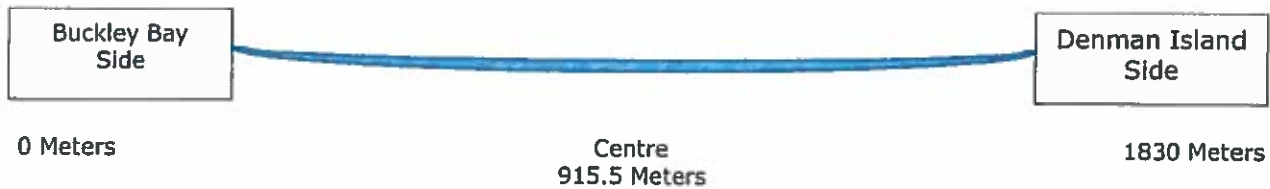
**BC Ferry Services Inc. - North Rope - July 20, 2016**

<b>Denman Island Ferry - North Rope</b>			
<b>Rope Construction:</b>	6 X 19 Seale	<b>Length:</b>	1830 meters
<b>Sens:</b>	2.42 - 2.05	<b>Diameter:</b>	1 5/8"
<b>Machine Used:</b>	LMA 300 (C)	<b>Av. Diameter:</b>	n/a
<b>Location</b>	<b>Comments</b>	<b>Rope Speed:</b>	1.2 m/sec (2.5 knots)
		<b>Location</b>	<b>Comments</b>
0	Start of test at Buckley Bay side	1171	One (1) broken wire
150	Two (2) calibration wires - 3" long	1176	Two (2) broken wires
457	One (1) broken wire	1177	One (1) broken wire
476	Two (2) broken wires	1180	Two (2) broken wires

476.5	One (1) broken wire	1198	Two (2) broken wires
478	One (1) broken wire	1200	One (1) broken wire - new
480	One (1) broken wire	1218	Two (2) broken wires
596	One (1) broken wire	1390	One (1) broken wire - new
621	One (1) broken wire - new	1760	Two (2) calibration wires - 3" long
642	One (1) broken wire	1761	One (1) calibration wire - 3" long
648	One (1) broken wire	1830	End of test at Denman Island Side
652	One (1) broken wire		
655	One (1) broken wire		
774	One (1) broken wire		
794	One (1) broken wire		
920	One (1) broken wire - new		
924	One (1) broken wire - new		
935	One (1) broken wire - new		
950	One (1) broken wire - new		
1090	One (1) broken wire - new		
1095	One (1) broken wire - new		
1105	One (1) broken wire - new		
1150	Two (2) broken wires		
1151	One (1) broken wire		
1152	One (1) broken wire		
1161	Two (2) broken wires		
1162	One (1) broken wire		
<b>Comments:</b>	<b>Untested cable: Denman Island to test head - approximately 10 meters and test head to excess cable on Buckley Bay - approximately 330 meters. Approximately 340 meters of cable not tested.</b>

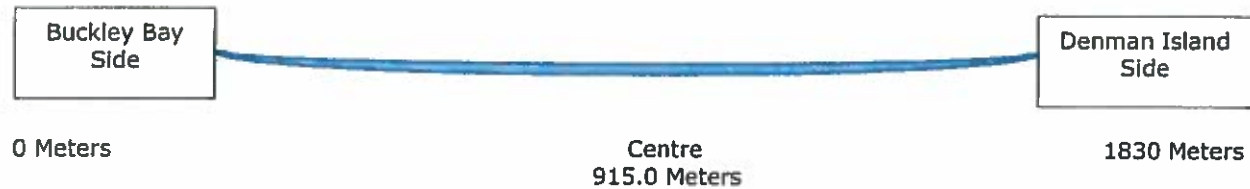
**BC Ferry Services Inc. - South Rope - July 20, 2016**

<b>Denman Island Ferry - South Rope</b>			
<b>Rope Construction:</b>	6 X 19 Seale	<b>Length:</b>	1830 meters
<b>Sens:</b>	2.42 - 2.05	<b>Diameter:</b>	1 5/8"
<b>Machine Used:</b>	LMA 300 (C)	<b>Av. Diameter:</b>	n/a
<b>Location</b>	<b>Comments</b>	<b>Rope Speed:</b>	1.2 m/sec (2.5 knots)
		<b>Location</b>	<b>Comments</b>
0	Start at Buckley Bay side	1109	One (1) broken wire - new
55	Two (2) calibration wires - 3" long	1112	One (1) broken wire
310	One (1) broken wire - new	1115	One (1) broken wire
362	1+1 broken wires & nick/abrasion	1116	One (1) broken wire
387	Two (2) broken wires	1118	One (1) broken wire
613	One (1) broken wire	1119	One (1) broken wire
754	One (1) broken wire	1125	One (1) broken wire
903	One (1) broken wire	1127	One (1) broken wire
908	One (1) broken wire	1128	One (1) broken wire
1021	One (1) broken wire	1129	One (1) broken wire
1024	One (1) broken wire	1134	One (1) broken wire
1025	One (1) broken wire	1135	One (1) broken wire

1029	One (1) broken wire	1140	One (1) broken wire
1044	One (1) broken wire	1141	One (1) broken wire
1050	One (1) broken wire	1144	One (1) broken wire
1054	One (1) broken wire	1146	One (1) broken wire
1056	One (1) broken wire	1147	One (1) broken wire
1057	One (1) broken wire	1149	One (1) broken wire
1062	One (1) broken wire	1152	One (1) broken wire
1064	One (1) broken wire	1153	One (1) broken wire
1070	One (1) broken wire	1156	One (1) broken wire
1078	One (1) broken wire	1157	One (1) broken wire
1086	One (1) broken wire	1158	One (1) broken wire
1088	One (1) broken wire	1163	One (1) broken wire
1090	One (1) broken wire	1164	One (1) broken wire
1095	One (1) broken wire	1165	One (1) broken wire
1097	One (1) broken wire	1728	Two (2) calibration wires - 3" long
1098	One (1) broken wire	1729	One (1) calibration wire - 3" long
1103	One (1) broken wire	1740	Two (2) broken wires (not visually located)
1104	One (1) broken wire	Some rope distortion - previously identified

1107	One (1) broken wire	1830	End of test at Denman Island side
<b>Comments:</b>	<b>Untested cable: Denman Island to test head - approximately 10 meters and test head to excess cable on Buckley Bay - approximately 330 meters. Approximately 340 meters of cable not tested.</b>		
<b>Specification:</b>	Quality Control
