Wire Rope Report

Baynes Sound Connector Cable Ferry
Asset #: 42076, 41878 and 41876
BC Ferry Services Inc.
Suite 500, 1321 Blanshard Street
Victoria, BC V8W 0B7
Canada

by
Inter-Mtn. Testing Ltd.

Job #: 7198
Date: December 13, 2016
Revision Date: January 17, 2017

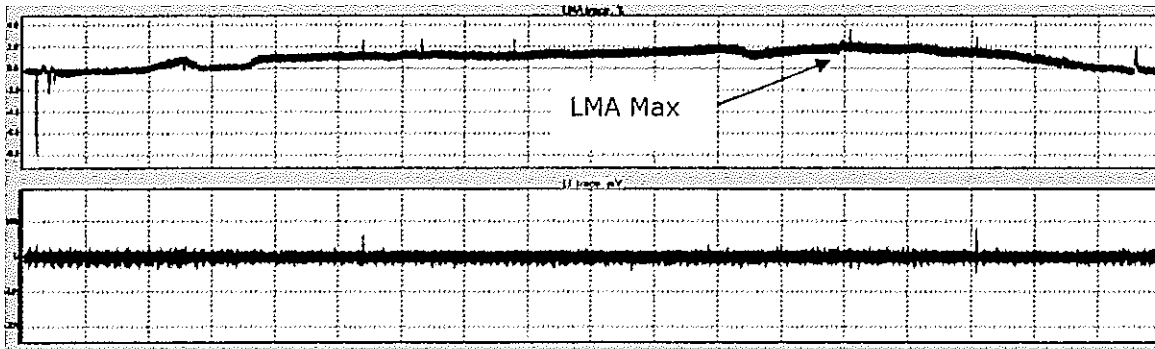
This wire rope was found to be in good condition at the time of this inspection, no significant changes since last test in July 2016. This rope has not been rotated since the last test in July 2016.

Above: Full view of trace (Buckley Bay start) - Overall loss of percentage as shown by Full View trace indicates overall loss of metallic area up to 2% plus individual areas of 1.00%.

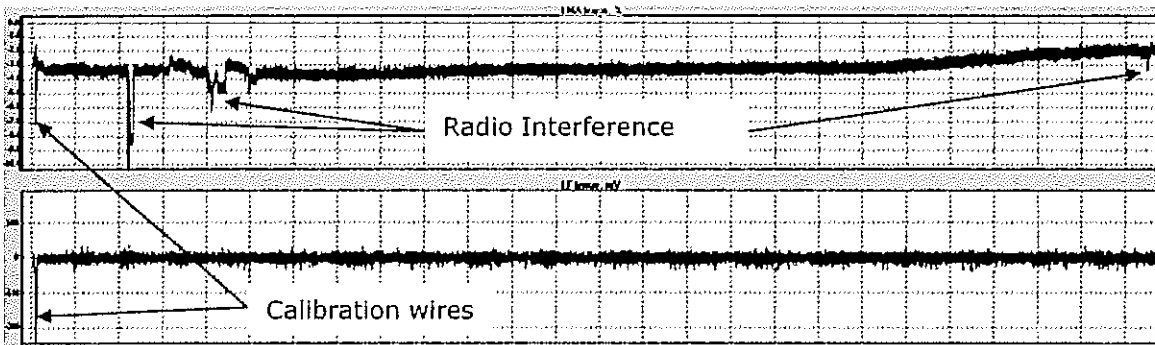
Above: Detailed view of calibration wires and radio interference

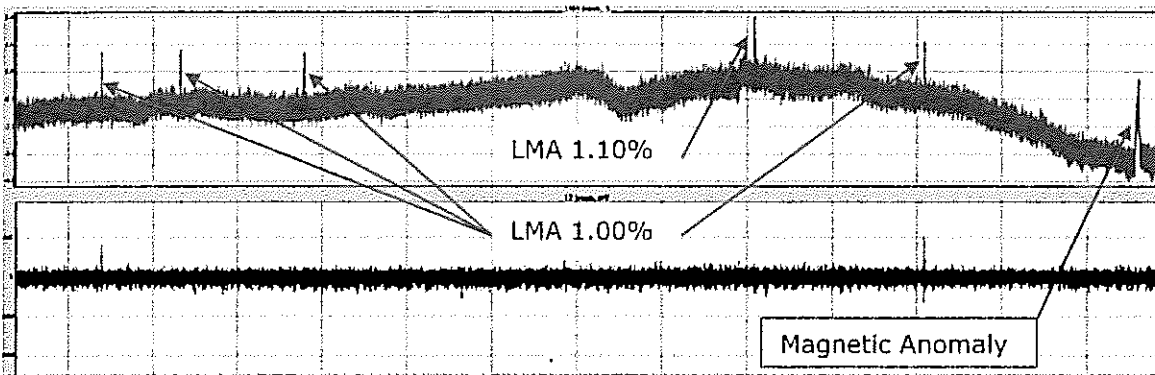
Above: Detailed view of LMA Loss and Gain

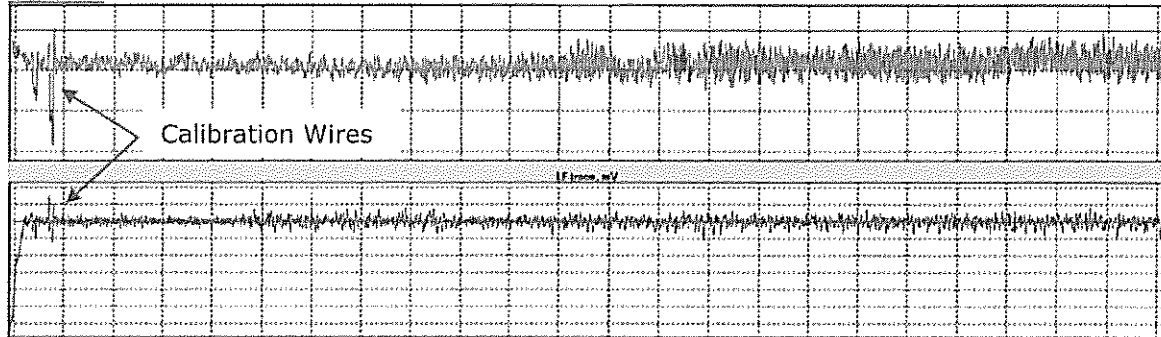
24.19m – Denman Island Side

Location (m):	Comments:
0	Start Test
0.82	1 x 3" Calibration Wire
1.11	2 x 3" Calibration Wire
24.19	End Test

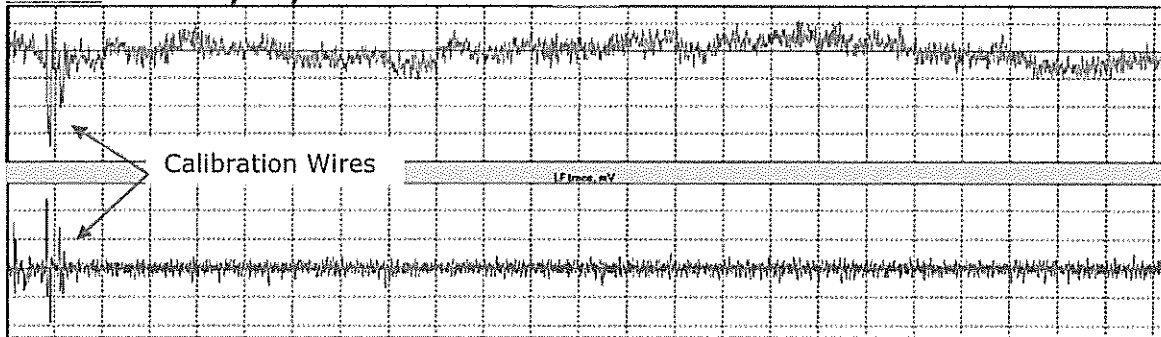
23.29m – Buckley Bay Side

Location (m):	Comments:
0	Start Test
0.31	1 x 3" Calibration Wire
0.68	2 x 3" Calibration Wire
23.29	End Test

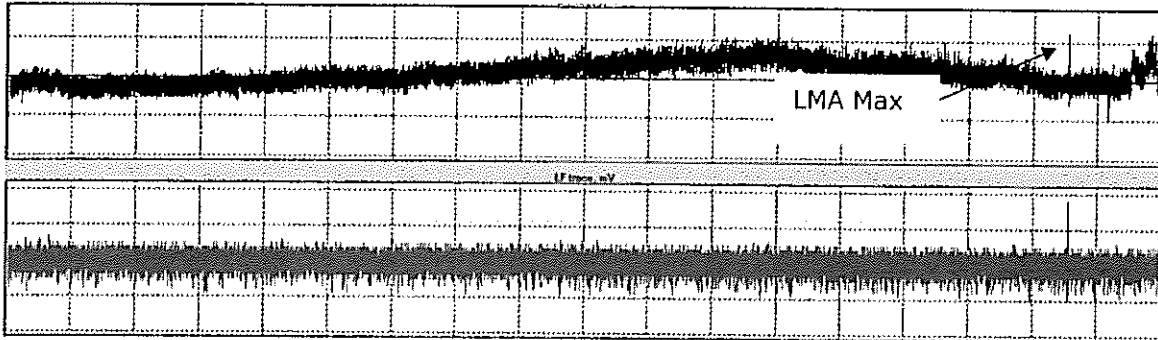
This wire rope was found to be in good condition at the time of this inspection with no significant LMA anomalies.

Above: Full view of trace (Denman Island start) - Overall loss of percentage as shown by Full View trace indicates overall loss of metallic area up to 1% plus Individual areas of up to 1.2%.

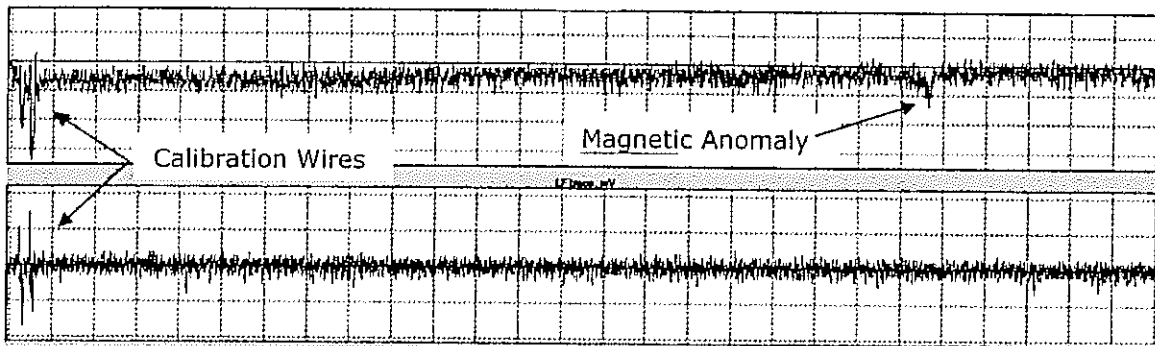
Above: Detailed view of calibration wires and magnetic anomaly

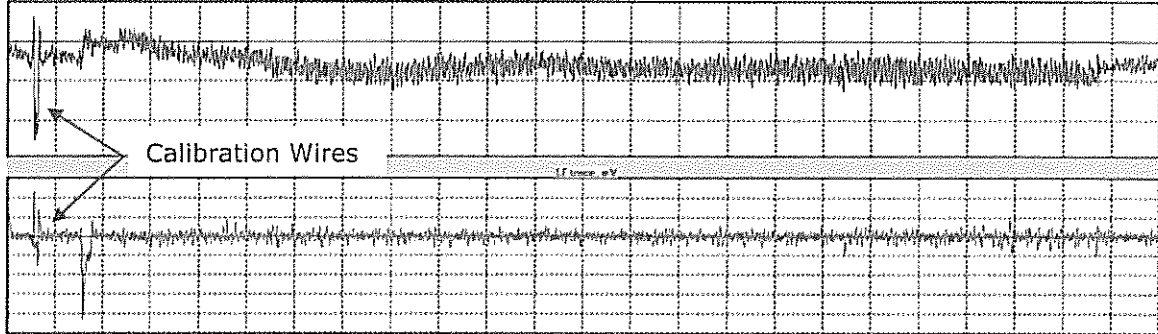
24.11m – Denman Island Side

Location (m):	Comments:
0	Start Test
0.58	3 x 3" Calibration Wire
24.11	End Test

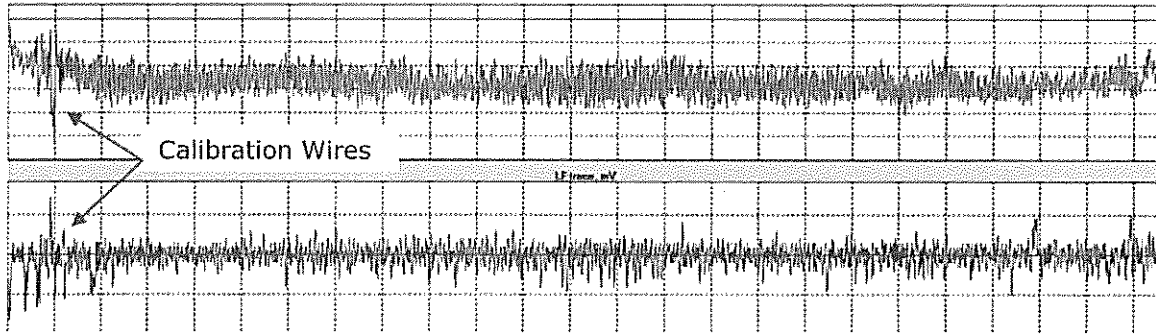
23.29m – Buckley Bay Side

Location (m):	Comments:
0	Start Test
0.6	1 x 3" Calibration Wire
0.9	2 x 3" Calibration Wire
24.66	End Test

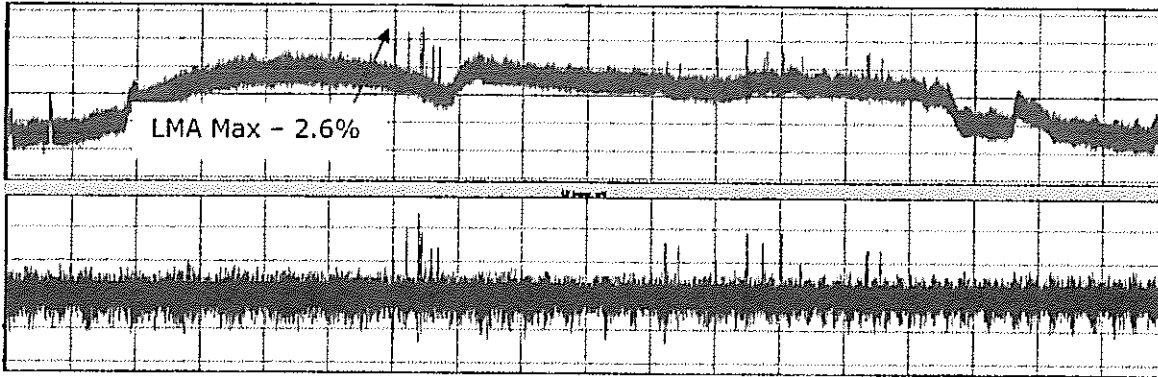
This wire rope was found to be in good condition at the time of this inspection, no significant changes since last test in July 2016. This rope has not been rotated since the last test in July 2016.

Above: Full view of trace (Denman Island start) - Overall loss of percentage as shown by Full View trace indicates overall loss of metallic area up to 2% plus individual areas of up to 2.6%.

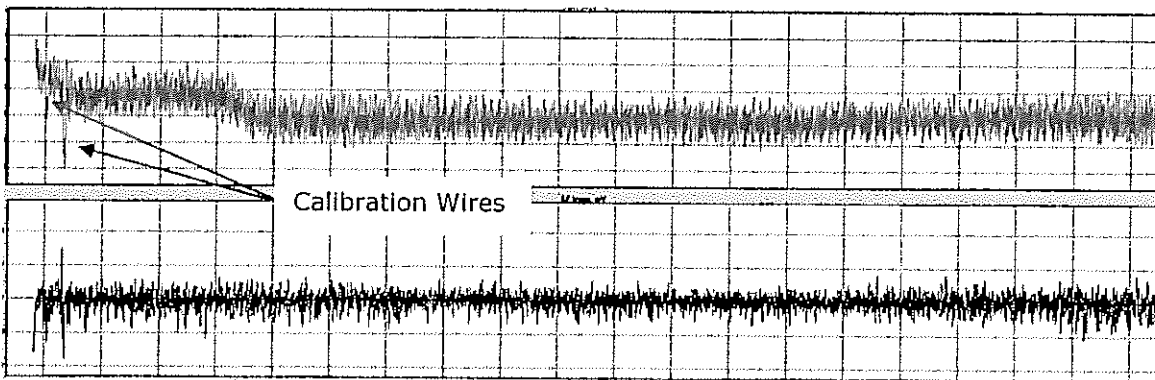
Above: Detailed view of calibration wires

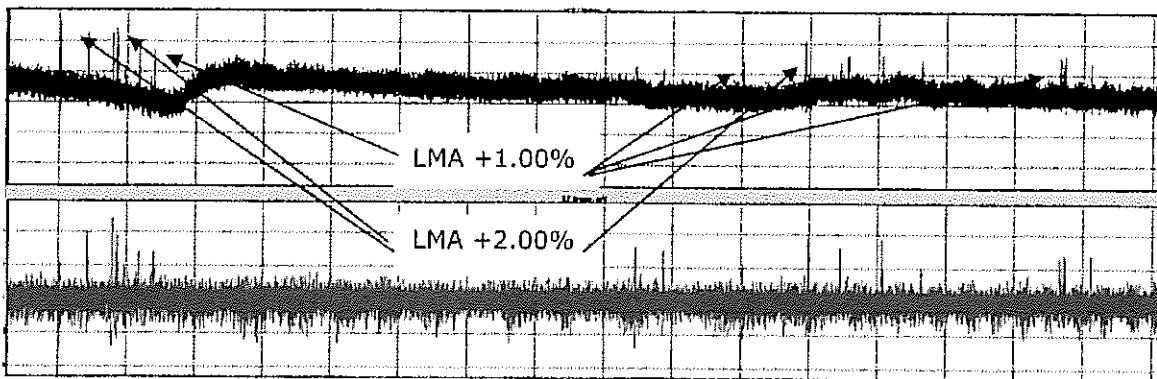
Above: Detailed view of LMA Loss and Gain

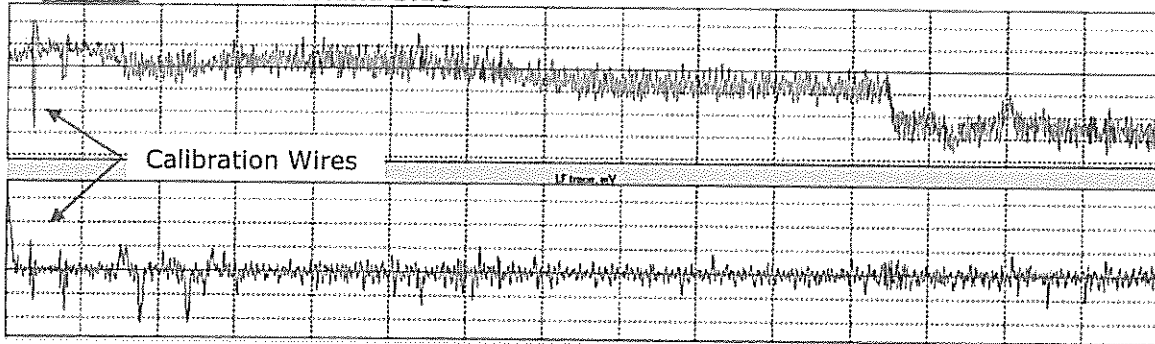
**North Rope – BCF Asset#: 41878
15.03m – Denman Island Side**

Location (m):	Comments:
0	Start Test
0.32	1 x 3" Calibration Wire
0.71	2 x 3" Calibration Wire
15.03	End Test

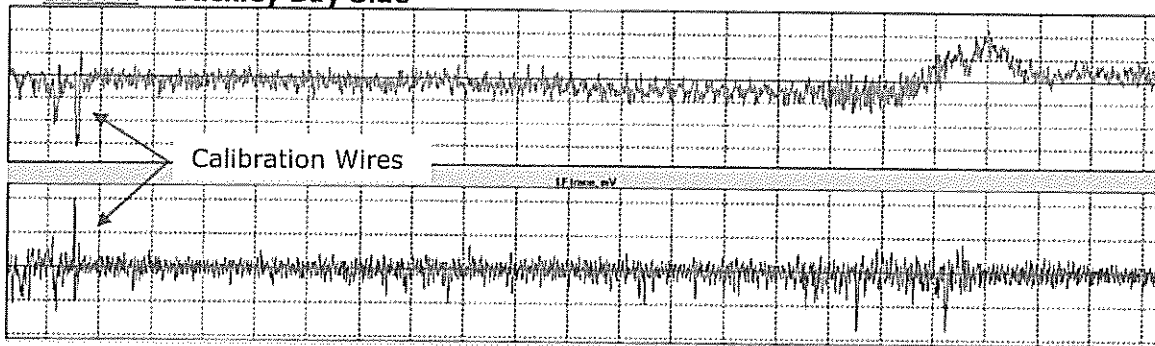
22.17m – Buckley Bay Side

Location (m):	Comments:
0	Start Test
0.9	1 x 3" Calibration Wire
1.3	2 x 3" Calibration Wire
22.17	End Test
