Wire Rope Report

Baynes Sound Connector Cable Ferry
Asset #: 42076, 41878 and 41876
BC Ferry Services Inc.
Suite 500, 1321 Blanshard Street
Victoria, BC V8W 0B7
Canada

by
Inter-Mtn. Testing Ltd.

Job #: 7198
Date: December 13, 2016
Revision Date: January 17, 2017

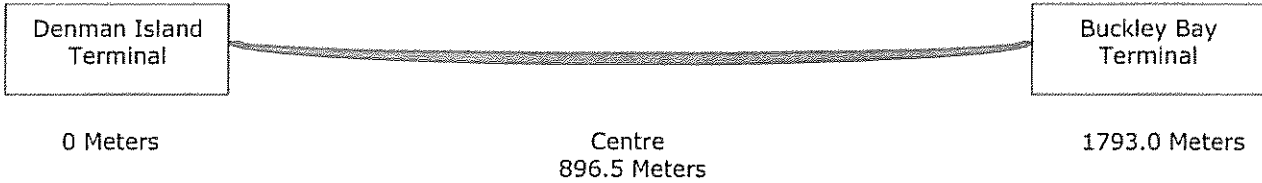
BC Ferry Services Inc. – BC Ferries Asset # 41878 – December 13, 2016

This wire rope was found to be in good condition at the time of this inspection, no significant changes since last test in July 2016. This rope has not been rotated since the last test in July 2016.

Baynes Sound Connector Cable Ferry – BC Ferries Asset #: 41878 – North Rope			
Rope Construction:	6 X 19 Seale	Length:	1793.1 meters
Sens:	92% @ 42mm	Diameter:	1 5/8"
Machine Used:	Wintros 24-64	Rope Position	North
Location	Comments	Location	Comments
0	Start of test at Buckley Bay side	1232.3	LMA Anomaly – 1.5%

0.4	1 x 3" Calibration Wire	1333.1	LMA Anomaly – 1.5%
1	2 x 3" Calibration Wires	1333.2	LMA Anomaly – 1.4%
448.4	LMA Anomaly – 1.5%	1334.4	LMA Anomaly – 1.3%
